Doc. No.: HS-195ENG	<h1 style="margin: 0;">IRATA</h1> <h2 style="margin: 0;">Safety Bulletin No. 44</h2>

## SAFETY BULLETIN NO. 44: ROPE ACCESS MAIN ROPE FAILURE

1.1 This safety bulletin summarises the findings of a main rope failure.

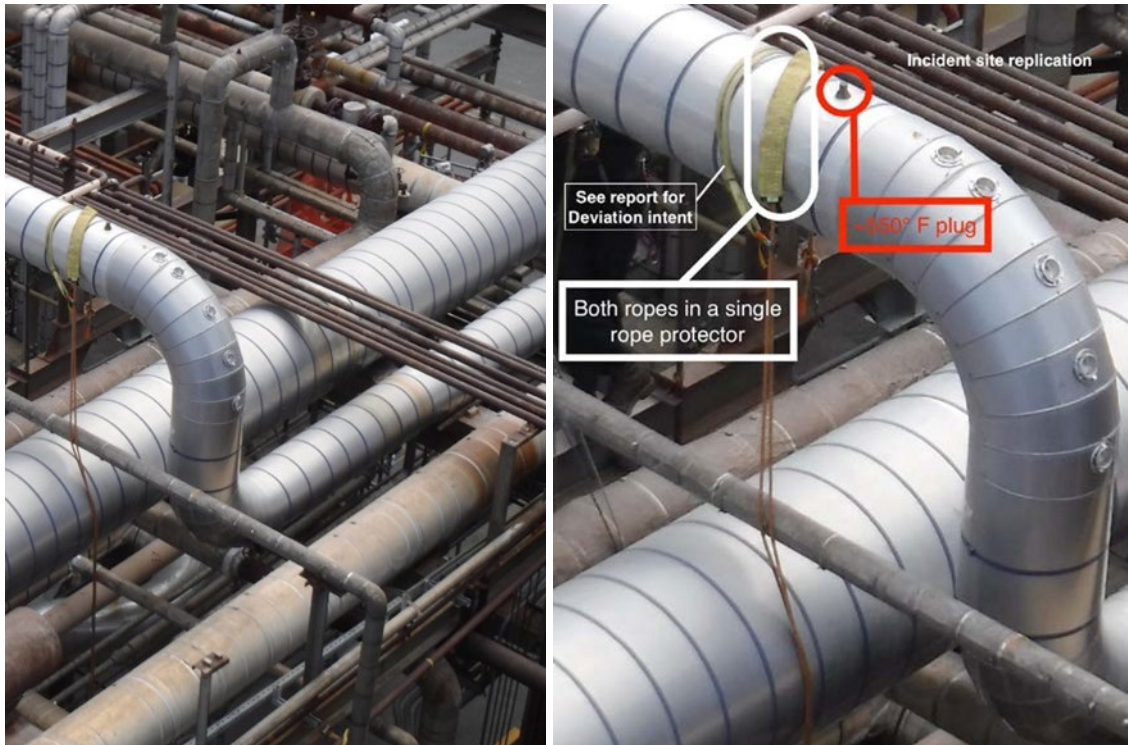
**Figure 1:** Recreation of the incident scene

3.2.1 A rope system was rigged by a Level 3 rope access technician over an insulated pipe, to establish a high-point deviation (sometimes known as an "up and over" directional). See **Figure 1**. Both the main rope and the safety rope were placed in a single, fabric rope protection sleeve to guard against rough and uneven surface hazards.

3.2.2 The technician ascended the ropes from ground-level. When the main rope was loaded, the system moved laterally such that it made contact with an exposed metal plug located on top of the insulated pipe.

**NOTE:** The surface temperature of the 1" diameter metal plug was found later to be approximately 550 degrees Fahrenheit (288 degrees Celsius).

- (ii) The deviation (see **Figure 1**, right) was intended to guard against a different hazard (viz. rope travel over the large pipe's elbow) and, therefore, did not engage the rope system early enough to prevent contact with the hot metal plug.

6.2 IRATA notes that, where possible, deviations should be “engaged” with the working rope, rather than set up to ‘catch’ the ropes if they move.

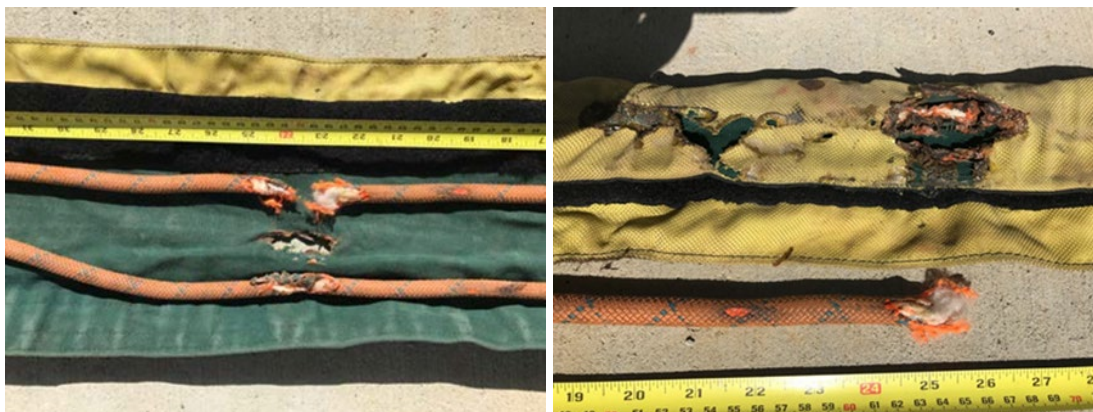
**Figure 2:** Damaged ropes and rope protector

3.2.3 Once the technician reached approximately 6 metres in elevation, the hot plug melted through both the rope protector (nylon/canvas) and the main rope to the point of failure. The technician fell approximately 1 metre until arrested by their back-up safety system. The technician immediately transferred body weight to the adjacent structure and, secured in position with an additional anchorage, waited until a new set of ropes were lowered into position.

- 3.2.4 After a safe descent was complete the team cleared the equipment, exited the unit, notified operations and stopped work.
- 3.2.5 An inspection of the damaged equipment involved showed that the main rope had melted through and the back-up safety rope had melted half through (approximately). See **Figure 2**.

- (b) The decision to place both ropes in a single rope protector exposed both the main rope and the safety rope to the same hazard simultaneously.
  - (i) Rigging/anchor angles were a contributory factor. The L3 technician decided that one rope protector was sufficient for potential sharp edges, based solely on the insulation bands encasing the hot pipe. When the technician, below, weighted the system the rope protector caused both the main rope and the safety rope to slide into the unrecognized hot plug hazard.

- (a) Establish enhanced awareness of high temperature hazards, regardless of type, e.g. exposed hot plugs, flanges, valves, etc. Identify and review them as part of any risk assessment and job planning.
- (b) Modify the company rope access procedures to highlight enhanced awareness of rope path.
- (c) Inspect the full path of the rope system, including potential movement, once the ropes are weighted; or ensure that all hazards are identified and are suitably mitigated.
- (d) Separate the main rope and safety rope, including rope protection, whenever possible to reduce the risk of concurrent damage or failure; reducing the risk of total system failure.
